Groundwater Resources for Lusaka and selected Catchment Areas

TECHNICAL REPORT NO. 2

A HYDROLOGICAL, HYDROGEOLOGICAL AND HYDROCHEMICAL CHARACTERIZATION FOR THE ESTABLISHMENT OF A CATCHMENT MANAGEMENT PLAN

Date: November 2015

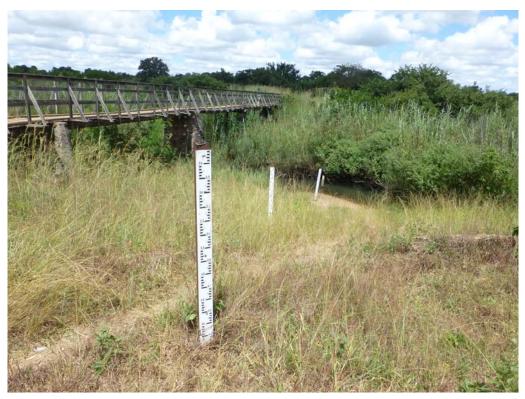
Figure 6: Gauging station 5-024 on Chongwe river after Ngwerere confluence, March 2015.
